AVIATION INVESTIGATION REPORT

A00C0260

COLLISION WITH TERRAIN

PIPER PA-31-350 CHIEFTAIN C-GZFK

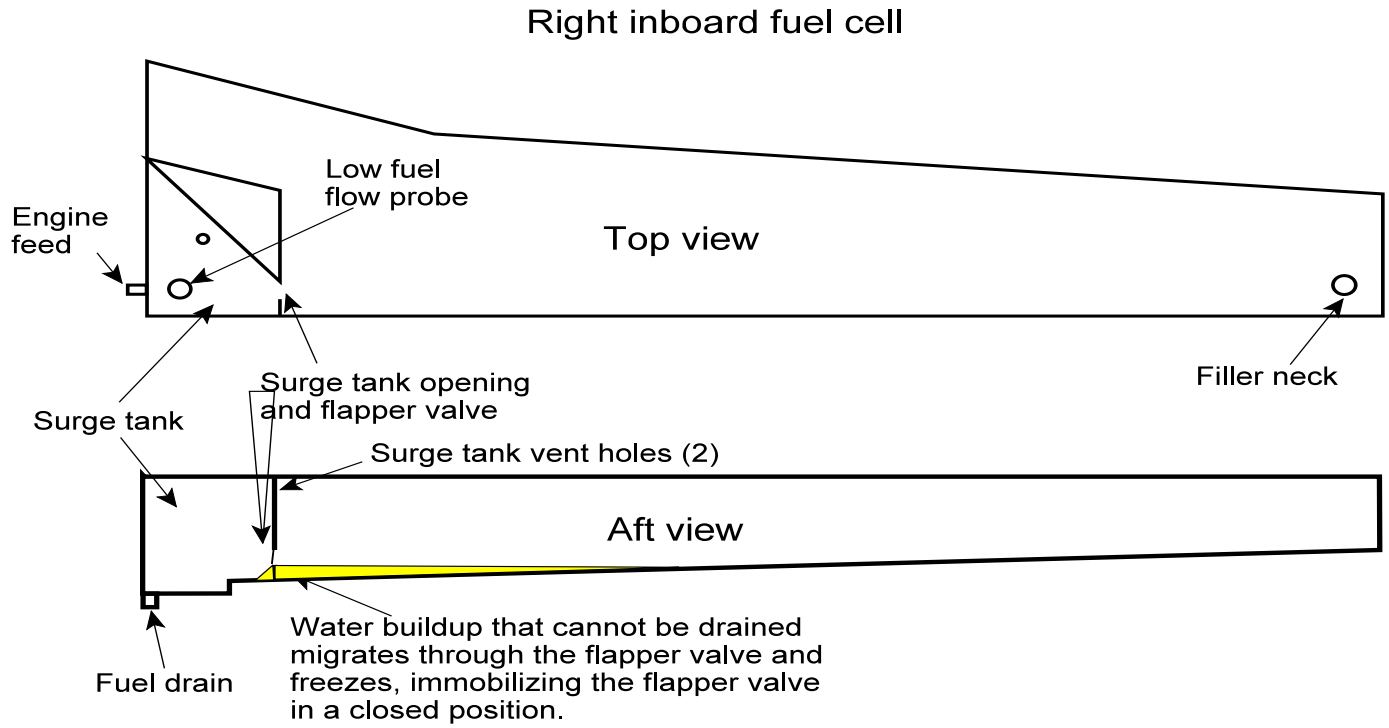
Appendix A—Fuel Cell Schematic

Each inboard fuel tank is partitioned into two segments (see Appendix A). The small segment, or surge tank, has a capacity of about four gallons and a purge (drain) valve; the engine draws fuel from this tank. A one-way flapper valve on the partition between the surge tank and the large segment allows fuel to flow into the surge tank. There is no purge valve in the large segment. A low-fuel sensor, installed in each surge tank, activates the respective fuel flow warning light in the cockpit when fuel starvation is imminent. Analysis of the cockpit warning lights indicated that the right fuel flow warning light was illuminated when the aircraft struck the ground. Examination of the inside of the large segment of the right inboard fuel tank bladder revealed a rust line up to the level of the flapper valve (see Appendix B). Fuel samples from the inboard fuel tanks were analyzed and found to be of normal quality.

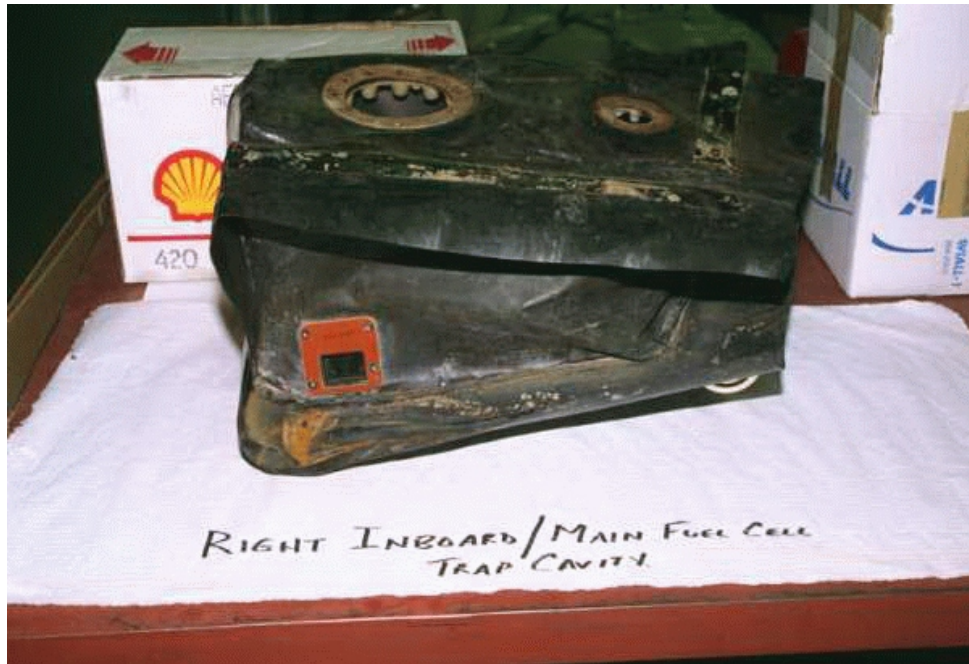
Illumination of the right fuel flow warning light and the serviceable condition of the right engine following the accident suggest that the right engine stopped because of fuel starvation. Rust in the surrounding segment of the right fuel tank indicates the presence of water up to the level of the flapper valve. This segment of the tank does not have a drain valve; water can therefore accumulate to the level of the flapper valve. Ice was found in the surge tank after the accident. It is probable that the water froze around the one-way flapper valve in the right inboard tank, obstructing the flow of fuel into the surge tank. When the inboard tanks were selected, the fuel in the surge tank was quickly depleted, the low-fuel sensor activated the right fuel flow warning light, and the right engine stopped because of fuel starvation. After the accident, the right surge tank refilled with fuel when the flapper valve began to move freely again as a result of either the ice melting or impact forces.

Figure 1 - Surge tank—shows the rust residue adjacent to the flapper valve

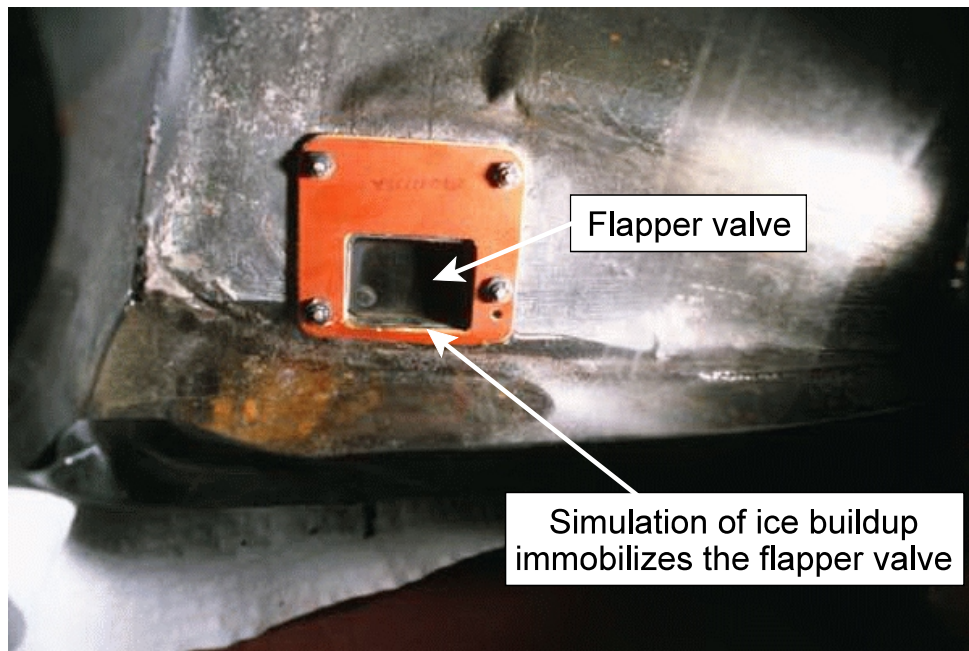
Tests were conducted at the regional Transportation Safety Board office to try to simulate water buildup and freezing of the flapper valve. The test was conducted in sub-zero temperatures. Water was allowed to collect outside the surge tank and adjacent to the flapper valve and spill over into the surge tank. The water froze and immobilized the flapper valve in the closed position (see Appendix B, Figure 2).

Figure 2 - View looking at the surge tank opening and flapper valve from the main cell area
